CASE STUDY

6,200 GALLON TANK TRANSFORMATION FROM BEAST TO BEAUTY

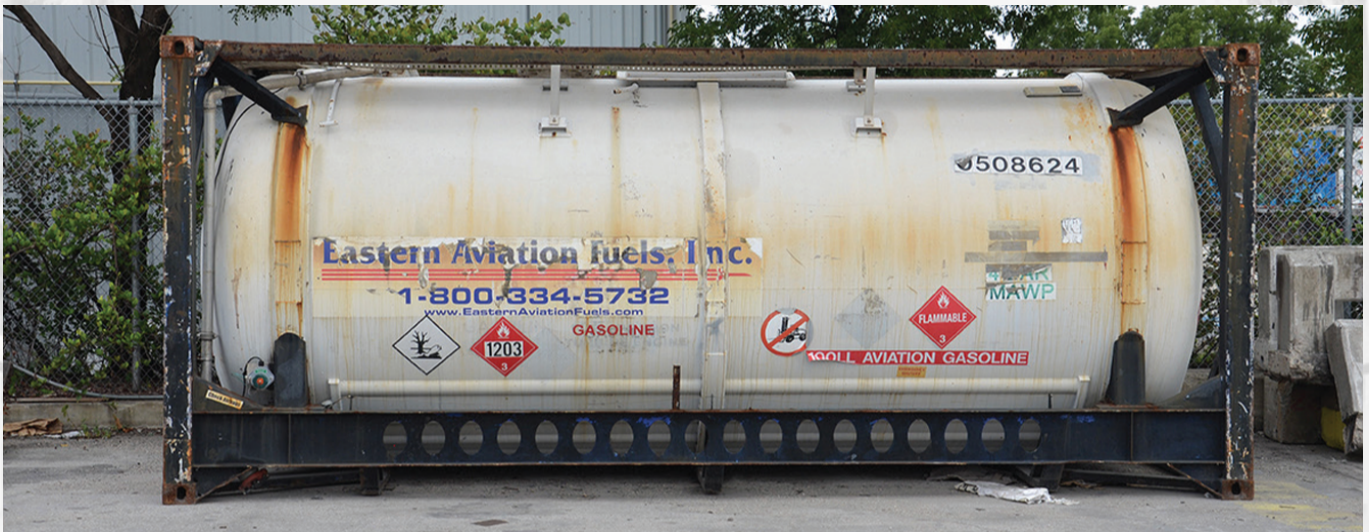
BEFORE

These 6,200-gallon tank containers were destined for the Caribbean but before they could be loaded with aviation fuel they needed **GEM** to recondition them. Because of the salt water exposure this tank would be exposed to in its new home, it needed the specialized care that **GEM** is well known for in the industry.

The tank was first water jet blasted to remove rust, old paint, and scaling. Next, it was sanded, given a coat of primer and coated with high-quality paint especially used for tank containers. The final step was installing their graphics. A true **GEM**-degree exterior makeover!
