## CASE STUDY

# MOVING LIVESTOCK FOR DISASTER RELIEF TO PUERTO RICO

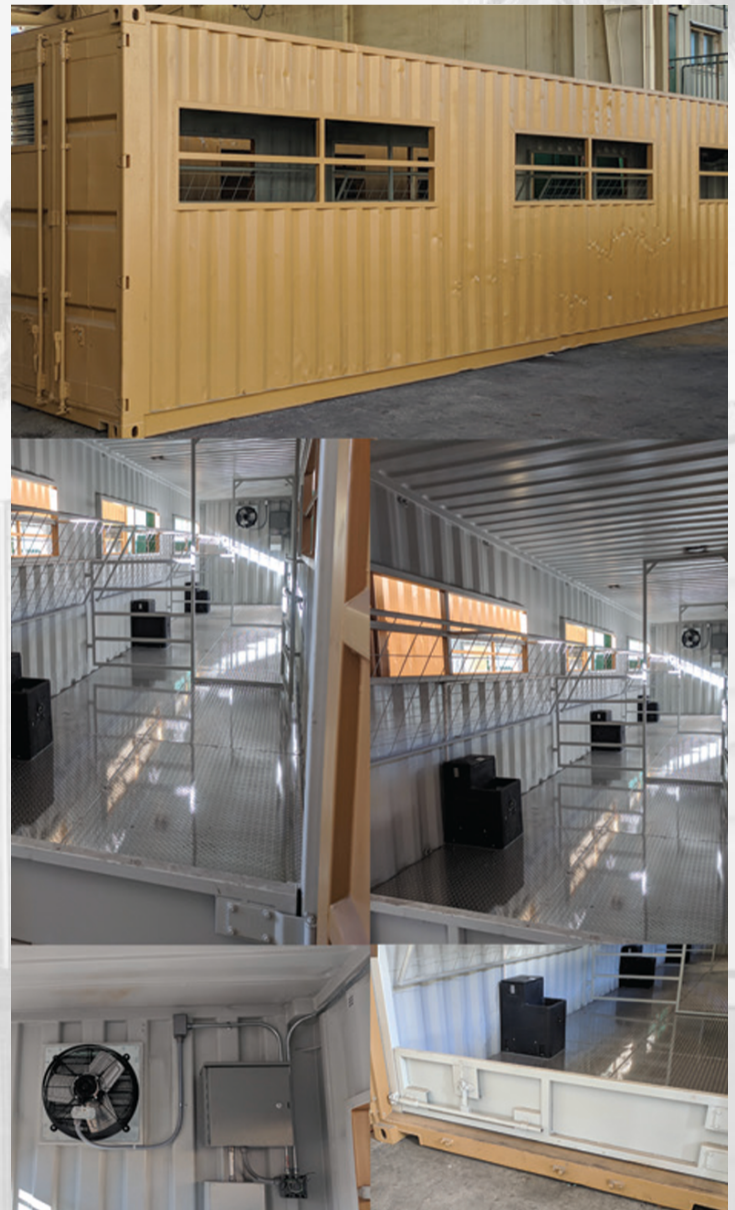
- **Modified cargo door widths**
- **Fully gasketed and sealed lower sill for waste containment**
- **Integral ventilation equipment in cargo doors**
- **Personnel access door for attendant**

The container cargo doors were modified to create an offset configuration which facilitated the load/unload of animals. Needless to say, cattle can generate a lot of waste, making the doors and accompanying waste containment a key factor in the design of the equipment. A gasketed lower sill assembly was implemented to handle the task. The ventilation & fresh air circulation system was integrated into the container cargo doors, allowing for fresh air to be continuously delivered.

While in transit the animals are attended to full-time by personnel. A small door was custom-built, allowing for the attendant to enter and leave the pens for watering, feeding, and any other concerns that would need dealt with in transit.
